**SUBJECT: COMPLAINT RE UNSAFE OBSTRUCTION OF PADDLERS' UTILIZATION OF THE WATER IN NEW MEXICO'S RIVERS AND STREAMS FOR RECREATION**

**Itemized Complaint to the New Mexico Attorney General re**  
Barricades and dangerous river fences on the Upper Rio Chama and the Upper Pecos River  
That deny or block recreational access and are life-safety hazards.  
Prepared by the Adobe Whitewater Club of New Mexico and the New Mexico  
Paddlers Coalition, incorporated New Mexico not for profit community organizations.  
September 15, 2023

### UPPER PECOS RIVER, Cowles to Pecos

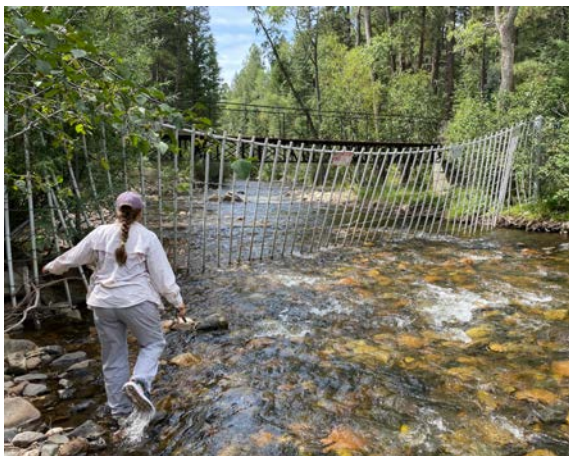
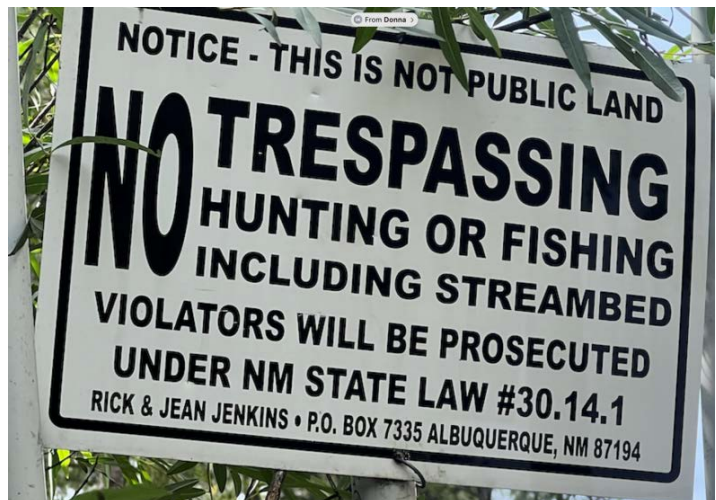
New Mexico river paddlers' access to the Upper Pecos River and the Upper Rio Chama are blocked by numerous cables and dangerous fences. One Intervenor-Respondent and the immediate upstream neighbor of another have blocked the Upper Chama River with a low cable and made access to a segment of the Upper Pecos River impossible, respectively. One landowner who applied for a certificate to privatize another segment of the Upper Pecos River below Cowles has blocked paddler access with a low cable.

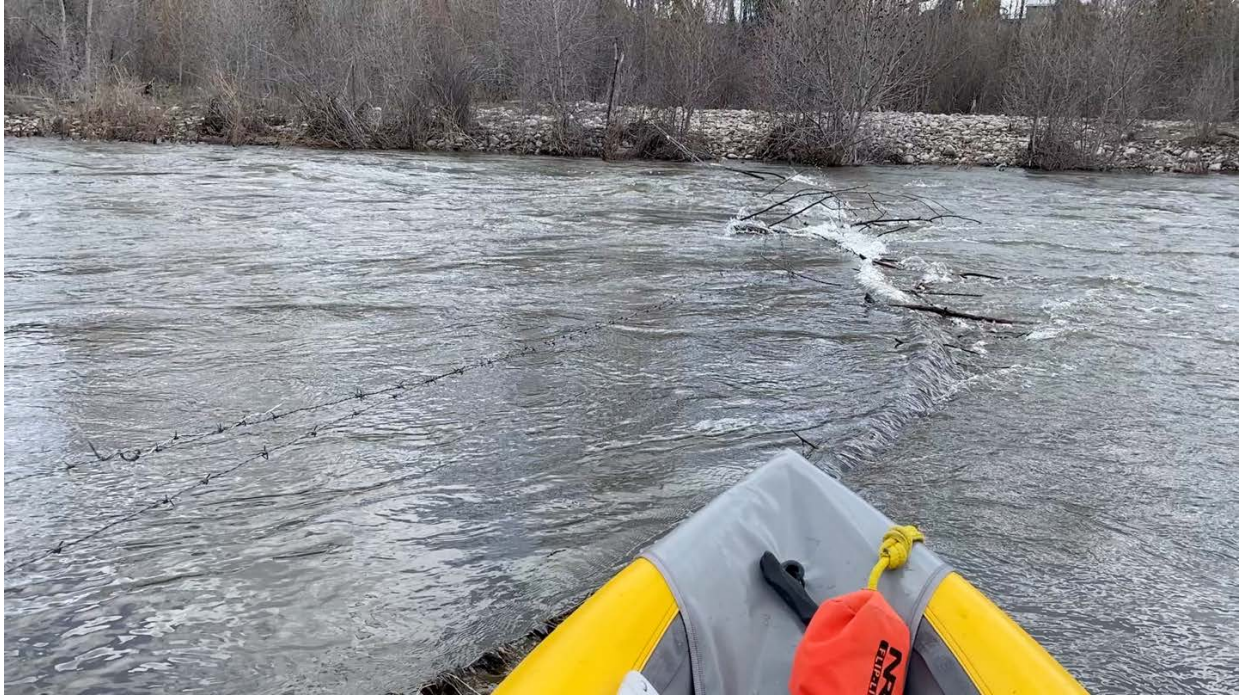
In the language of your August 7 Press release, “fences consist[ing] of barbed wire at or below the water line, constitut[e] a clear public safety hazard for anglers and others accessing public waters.” Several cases documented in this complaint present a life-safety hazard to river paddlers utilizing the water in New Mexico streams and rivers for recreation. Barbed wire fences with

brush or steep adjacent slopes limit access to seniors who may not be able to carry a boat 100 yards or more for mandatory portage,

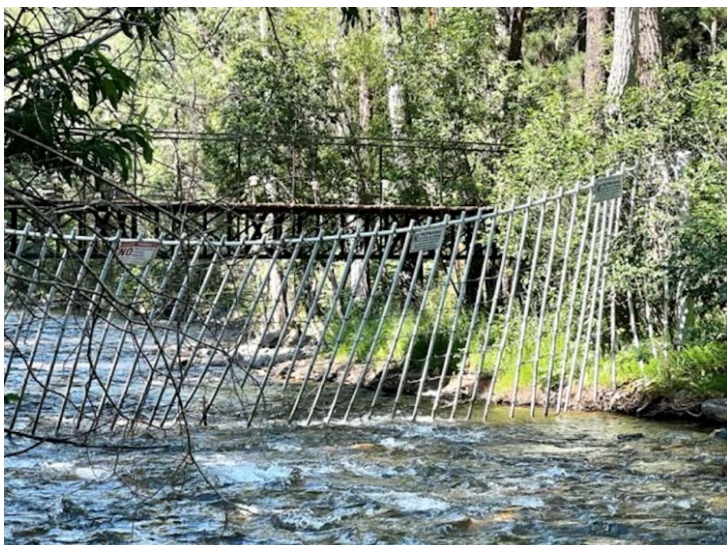
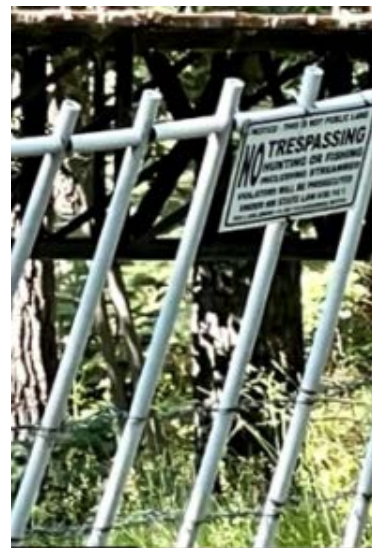
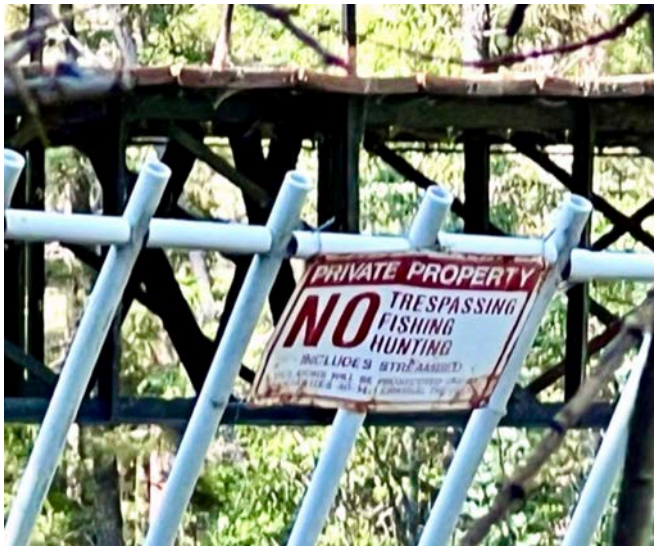
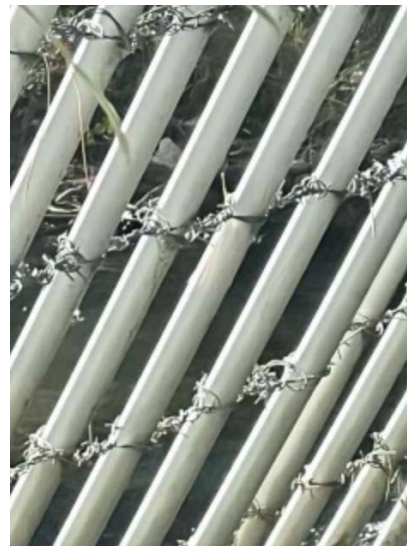
appear to align with Old Leaning Pine, LLC's (Jenkins) upstream property boundary. The second barricade, which was not visible on September 10, appeared to have been at the upstream boundary of multiple lots owned by the Kenneth and Julie Hersh trust. The remaining upstream barricade is impassable and life threatening to a paddler. Both are/were constructed of vertical pipe and barbed wire, as illustrated below. A photo of the Hersh barricade was an exhibit in the verified petition for a writ of mandamus.

I just returned from a trip to the Hersh "compound" on the Upper Pecos River, about 16.5 miles up from the 4-way stop in the middle of Pecos. One can identify the 230+ acre property easily because of the razor wire surrounding it. The Hersh property is one of the 5 original properties that were declared non-navigable and closed under the Martinez Administration (Rule 19.31.22), and that the Lujan Grisham administration is ignoring. Today I found the same significant barrier at the northern boundary of the Hersh property that I photographed in October 2022, only now a high bridge has been added across the river on the Hersh side. This north boundary is immediately adjacent to NM Game & Fish property that is now managed by NM State Parks. This public day use area is still in sad shape due to last summer's fires and is currently closed to public use. Here are photos from today of the northern Hersh/G&F property boundary:

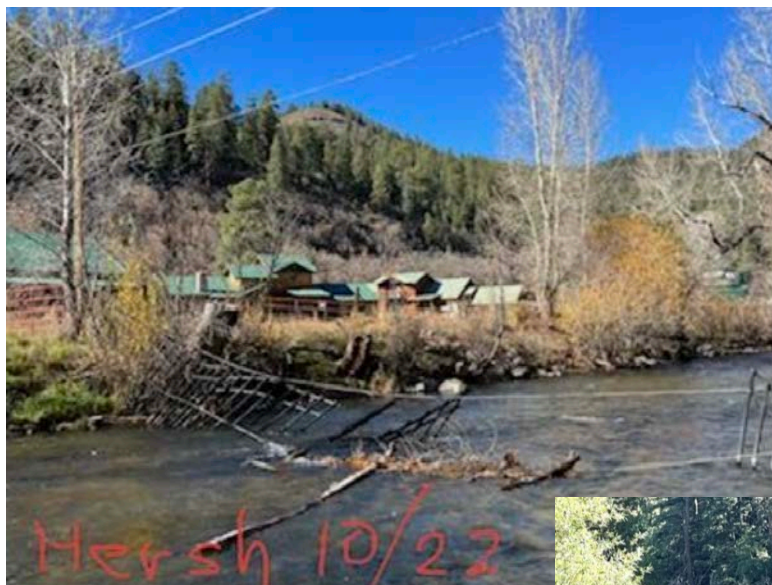
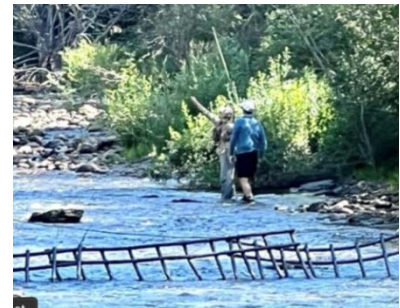
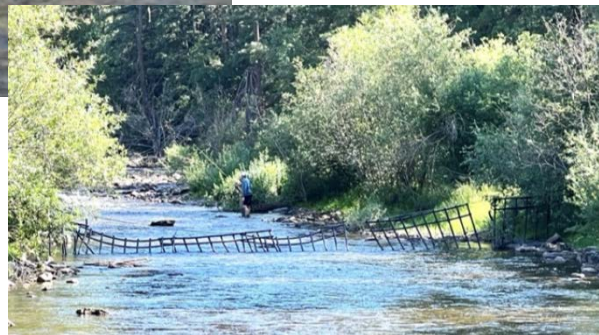
The photographs included in the Attorney General's news release are of the downstream barricade demarking the privatized section of the river flowing through the subdivided Hersh and Jenkins properties (Rio Dulce Ranch) properties and the adjacent downstream subdivision with cross-river lots. The downstream barricade shown in the top photo labeled 10/22 is depicted in disrepair with upper and lower cables crossing the river but stripped of some of the vertical pipe. The barricade is repaired in the bottom photo taken July 20, 2023. Inspection on September 10, 2023, showed it to be unchanged.

On the southern boundary of this long river reach that includes more lots downstream of the Hersh lots, an apparently new barrier has been installed to replace/repair the damaged barrier photographed in October 2022. This southern boundary is also immediately adjacent to NMDG&F property, the Jamie Koch Pavilion and Day Fishing Area. Here is the photo I took last October, followed by today's photos; note the two men fly fishing on the "privatized river" side of the barrier.

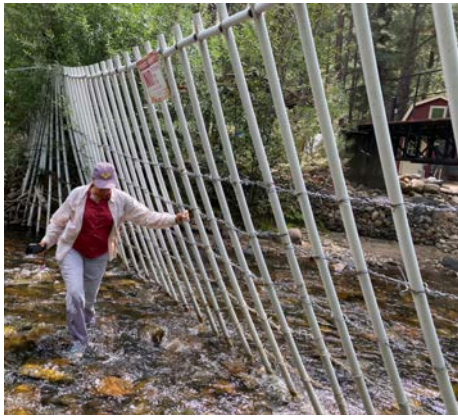
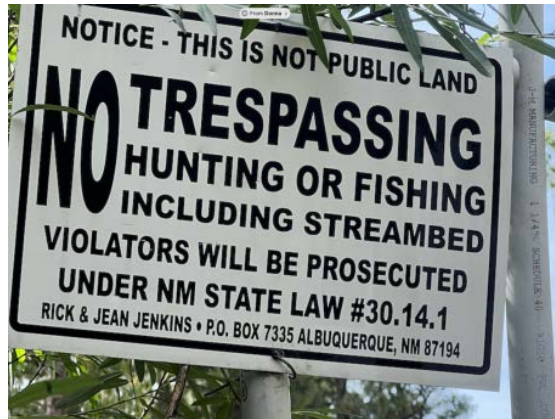
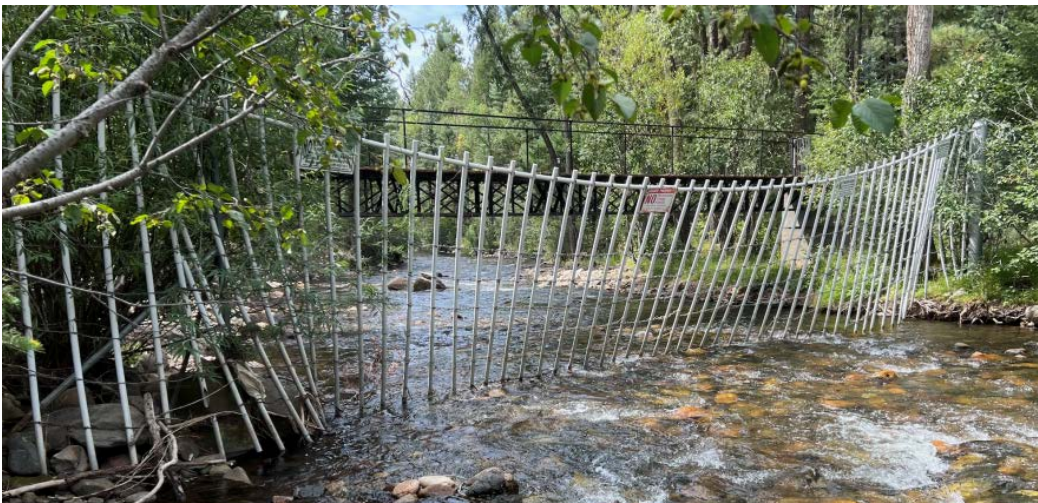
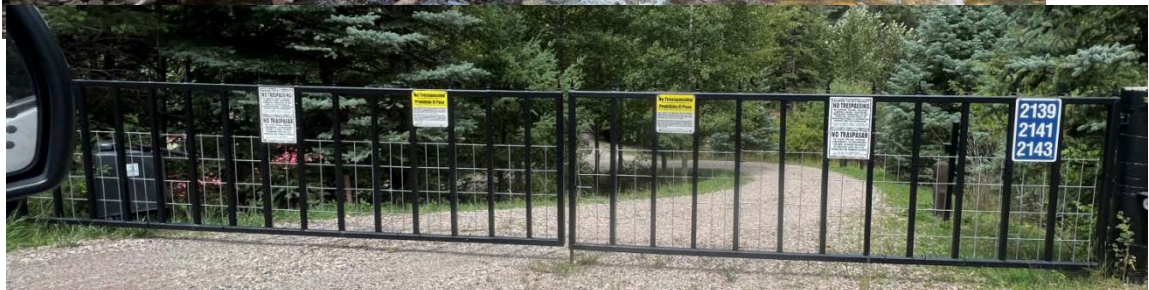
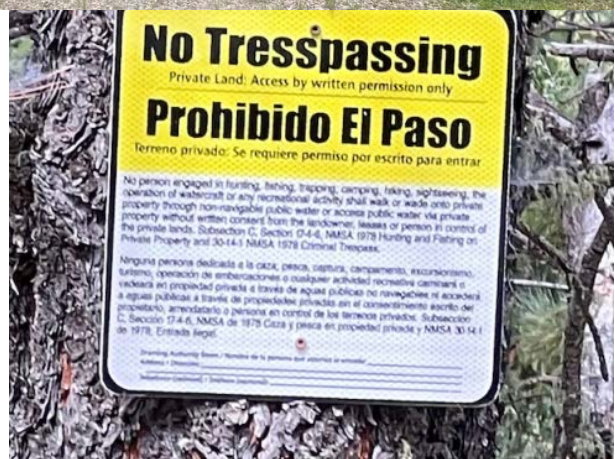
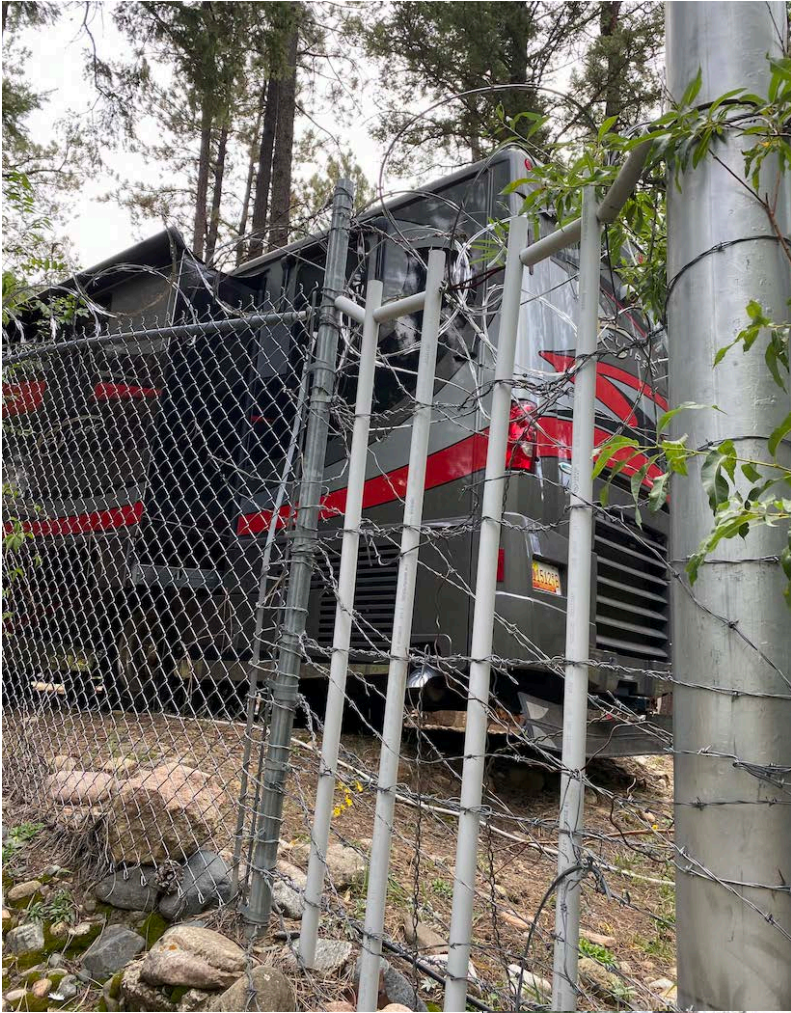
### Jenkins Leaning Pine PVC River Barricade, Sign, Driveway Gate

The center photo in the news release depicts the "NO trespassing...includes streambed" sign depicted in the on page 1 of this complaint, believe to be at the Jenkins property line. The flanking fence makes portage impossible, completely blocking access to members of the public who wish to utilize the public water for recreation as is their NM Supreme Court affirmed constitutional right.

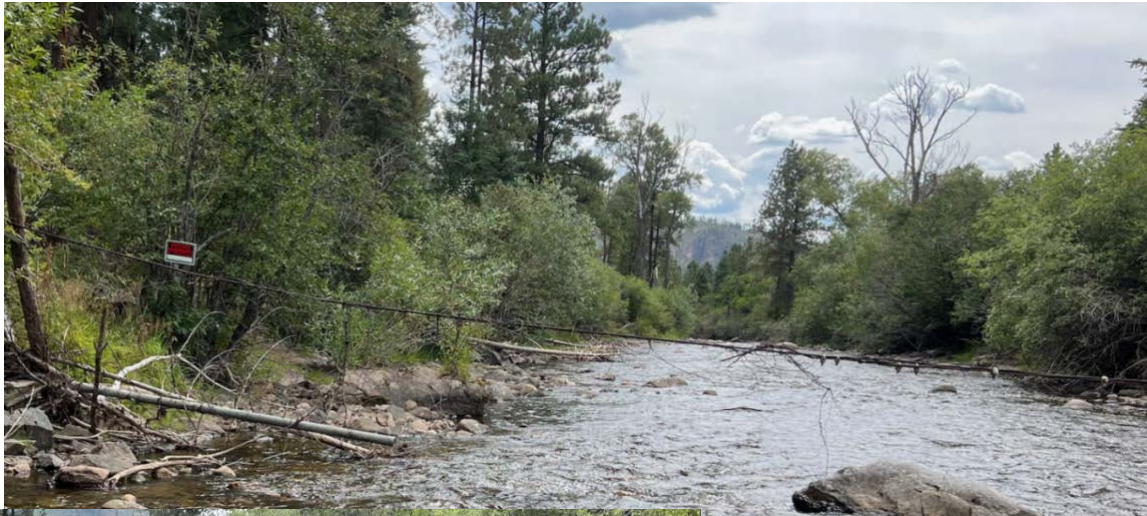
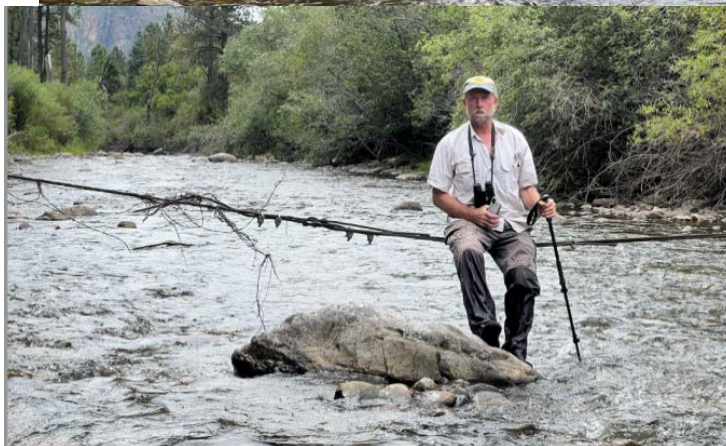
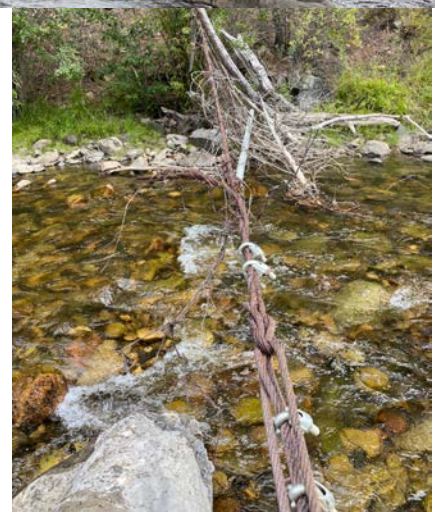
**2. Mary Anne Shannon Upstream Property Boundary, Downstream of Bert Clancy  
Public Fishing access: 35.73341, -105.67758**

A cross-river cable is located 800 feet downstream of the Bert Clancy Public Fishing access. Mid-river splices and shoreline fencing make this cable especially dangerous. The steel cable is 36" above water at 30cfs flow.

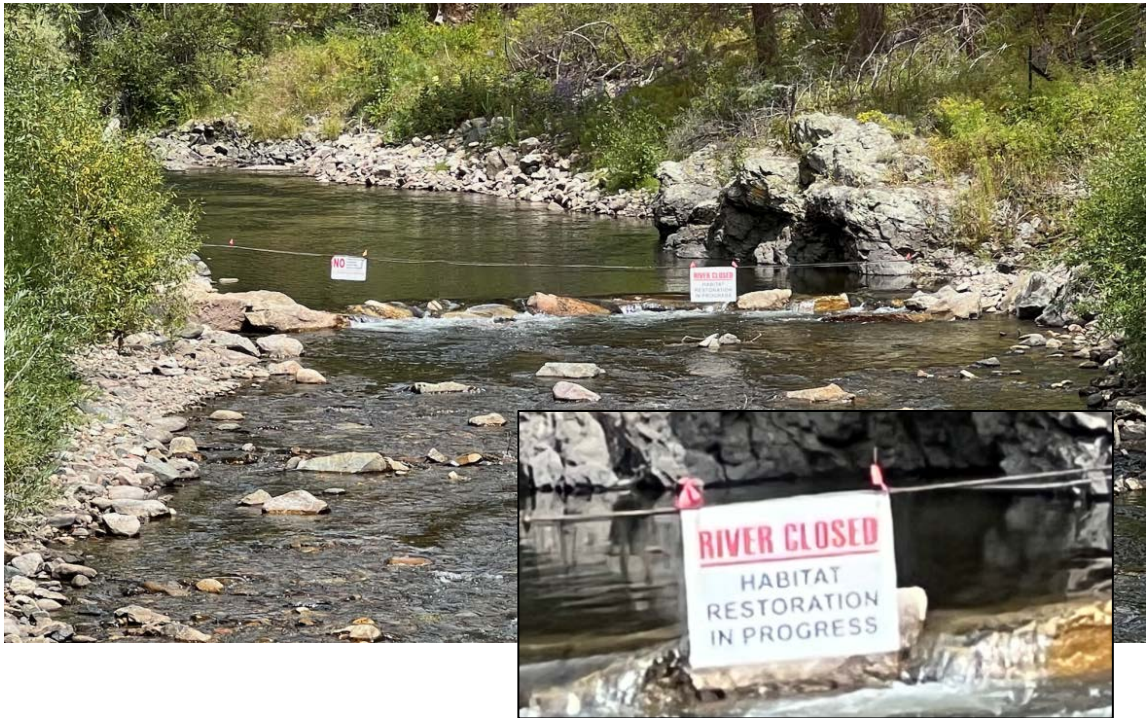
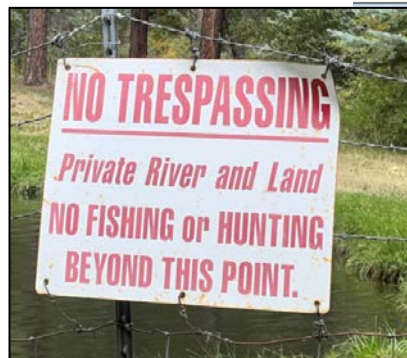
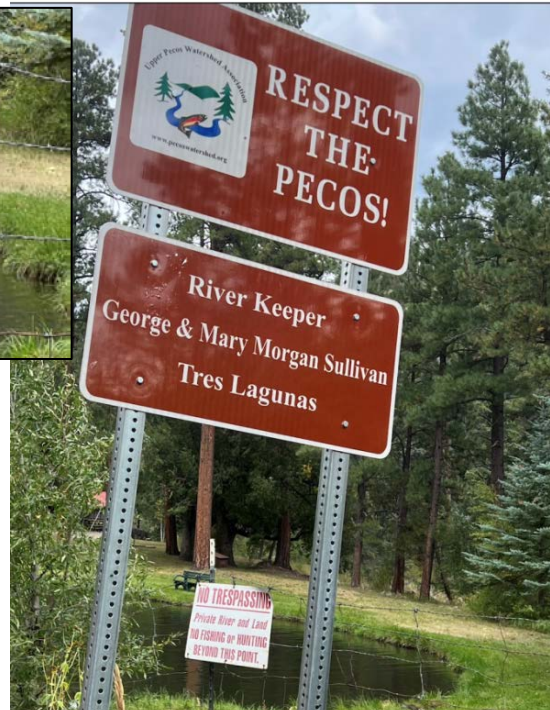
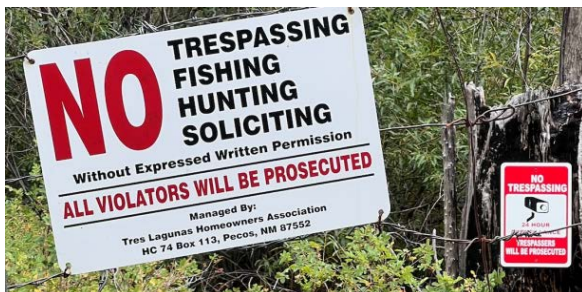
### 3. Tres Lagunas subdivision: 35.71966,-105.67819

A cross-river cable is visible from highway 63 near the Pecos River Keeper sign posted at the downstream boundary of the Tres Lagunas subdivision. There are two signs on cable mid-river facing downstream. The steel cable is 24” above water at 30cfs flow. The Tres Lagunas subdivision downstream boundary is posted with “Private River” signs next to the highway.

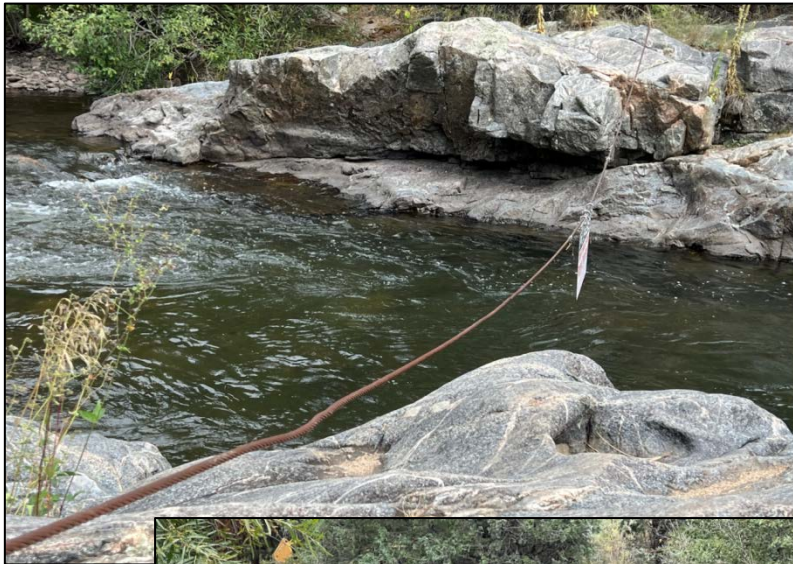
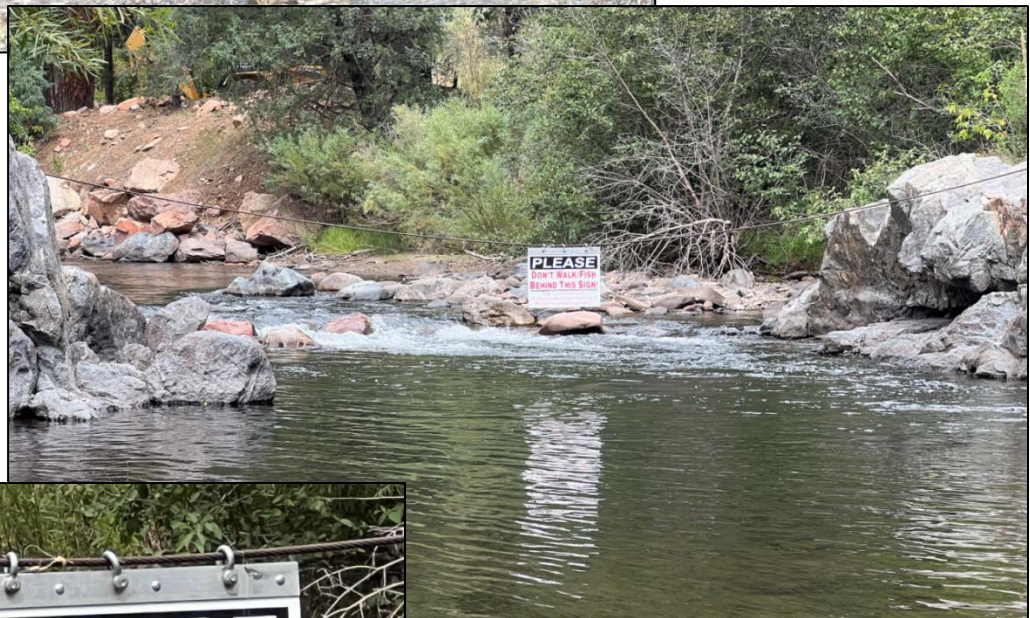
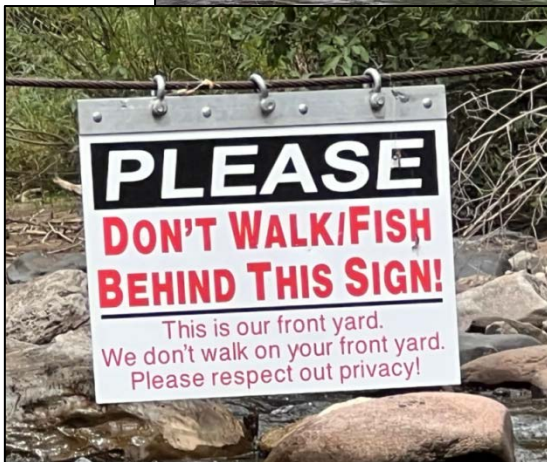
**4. Cable at downstream boundary of the Kinney tracts: 35.6652, -105.68602**

This cross-river cable visible from river 500' upstream of mile marker 13 Highway 63. Known roadside river access point for short paddle down to Upper Dalton fishing access area. One sign on cable, facing downstream mid-river. It is suspended between two large riverside boulders 36" above the water surface at 30cfs flow.

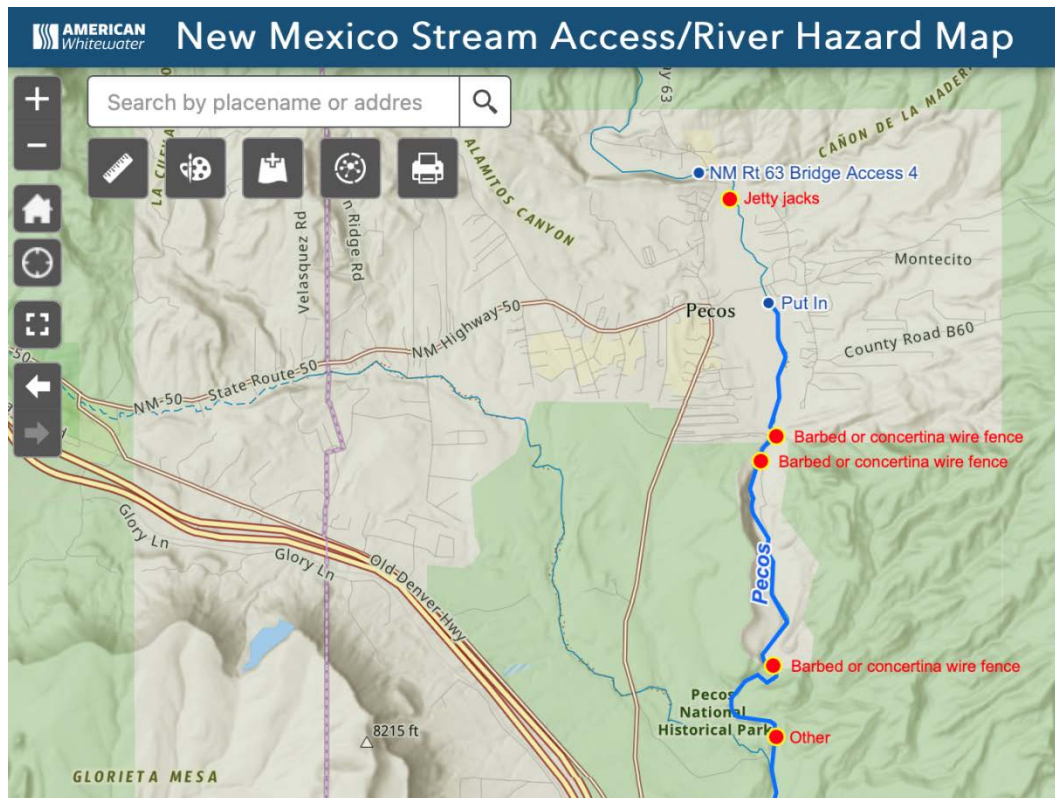
Steel posts projecting horizontally into the Pecos River and two hazardous river fences that require portage or can be passed in a boat only with assistance are described in complaint cases 5 through 7. They are located at the three upper red dots on the map below.

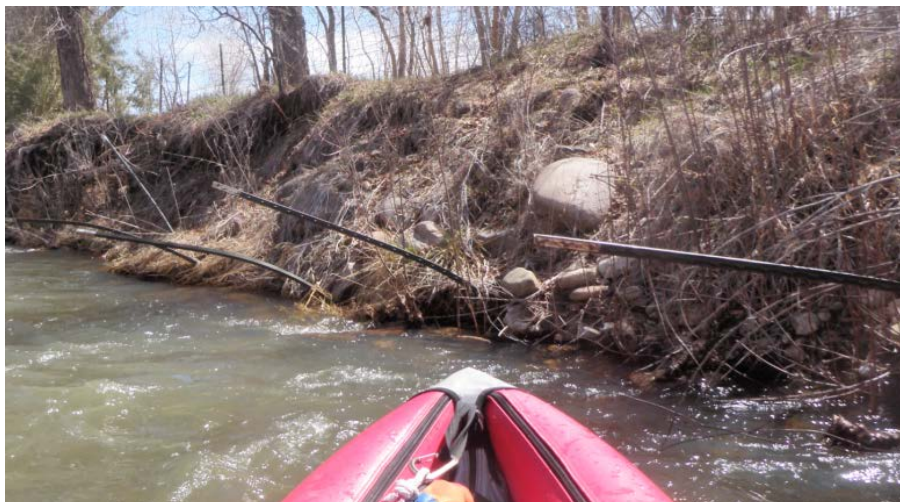
- 5. Unknown Owner.** Several T-Bar posts are angled into current from river right shore at water/boat level. This location is shown with the uppermost red dot labeled "Jetty jacks" on the Upper Pecos River map, upstream of Pecos, New Mexico. These posts are a very dangerous entrapment hazard for boats and paddlers particularly for high water conditions when the posts would be mostly submerged.

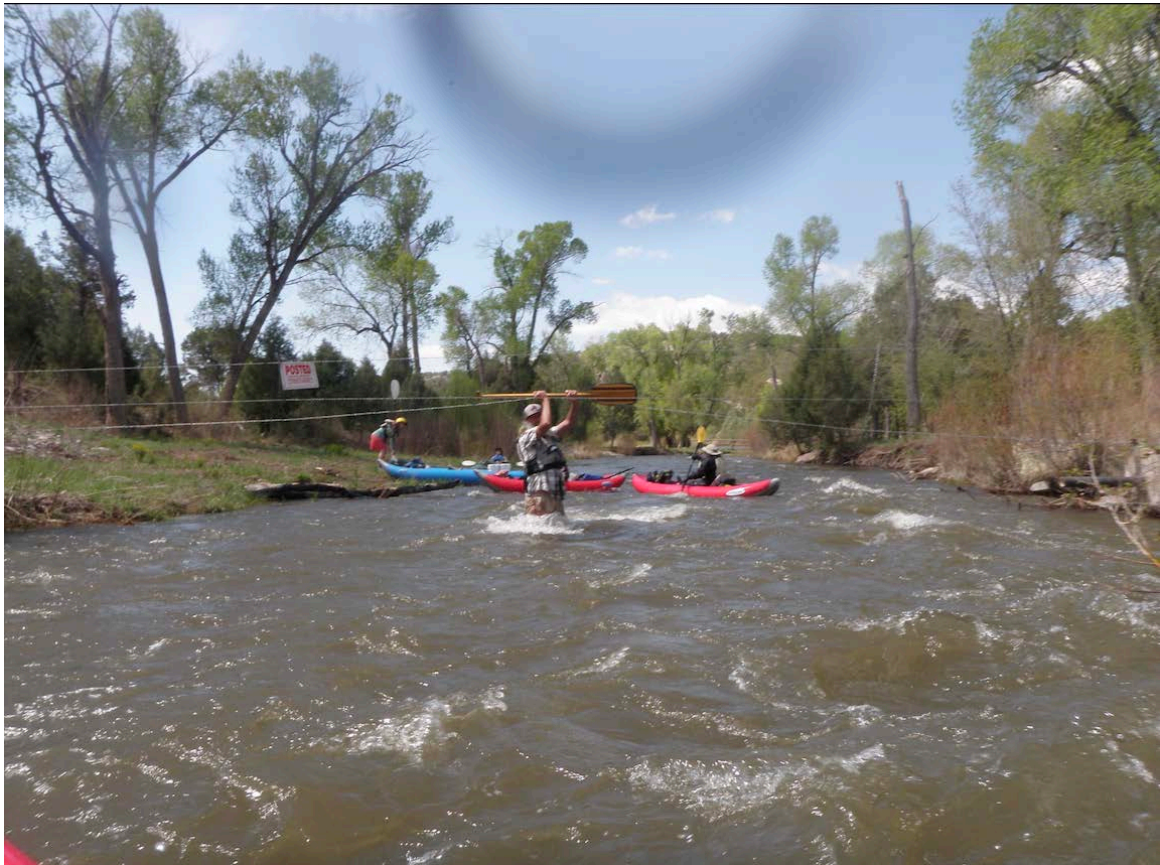
6. This complaint includes two cross river barbed wire fences downstream of Pecos, New Mexico. Both are located most upstream property of the Royal Oaks subdivision believed to be controlled by Edward T. Garcia, a member of the State Game Commission, Respondent. Our inspection on September 15 showed both fences had been removed by or for the high water this year. The fences were strung out in the water along the bank. The second fence was the same.

**Garcia Sheliah P Trust.** A cross-river posted barbed wire fence is located immediately below the town of Pecos. It appears to be at the upstream property boundary of the Garcia Trust lot. The fence could entrap and drown a paddler without the skills to stop in the swift current.

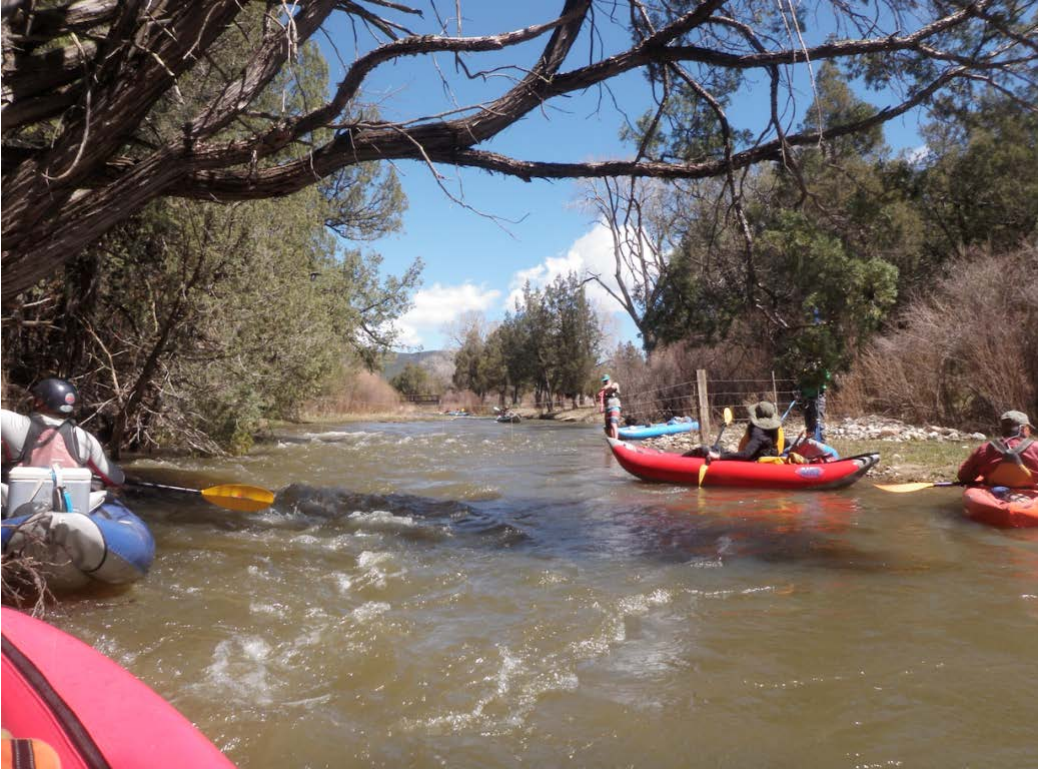
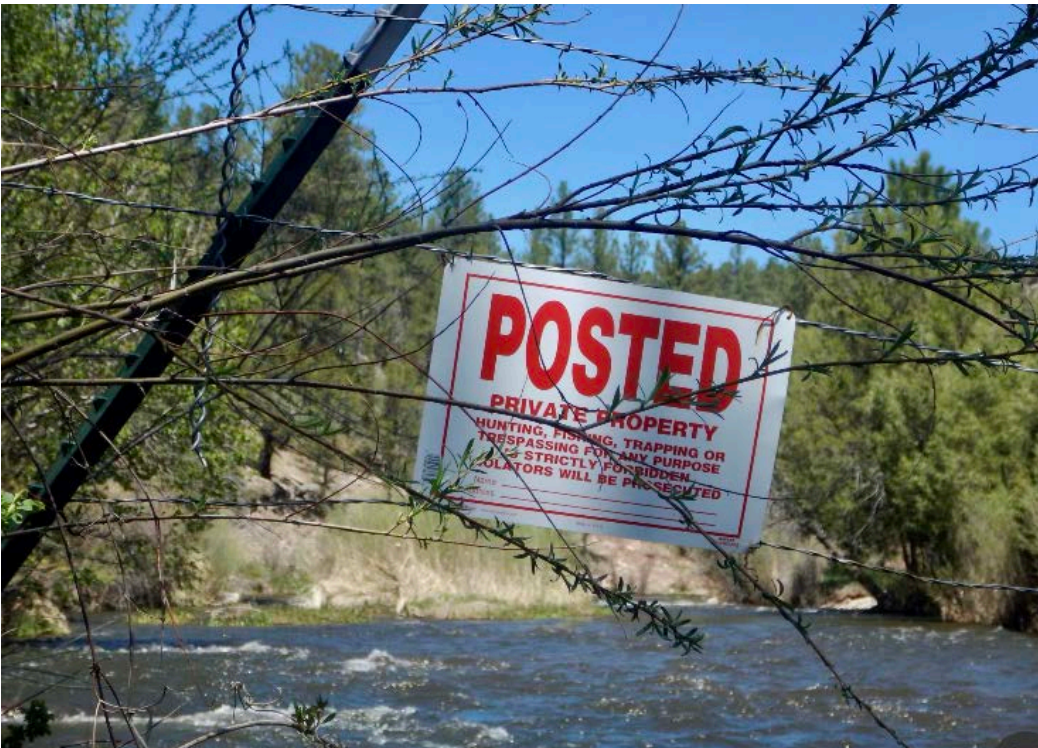
7. **Garcia Sheliah P Trust.** A second hazardous fence in this river segment is located not far downstream as illustrated in the area map above. The photo shows the fence is not far downstream of the vehicle bridge.

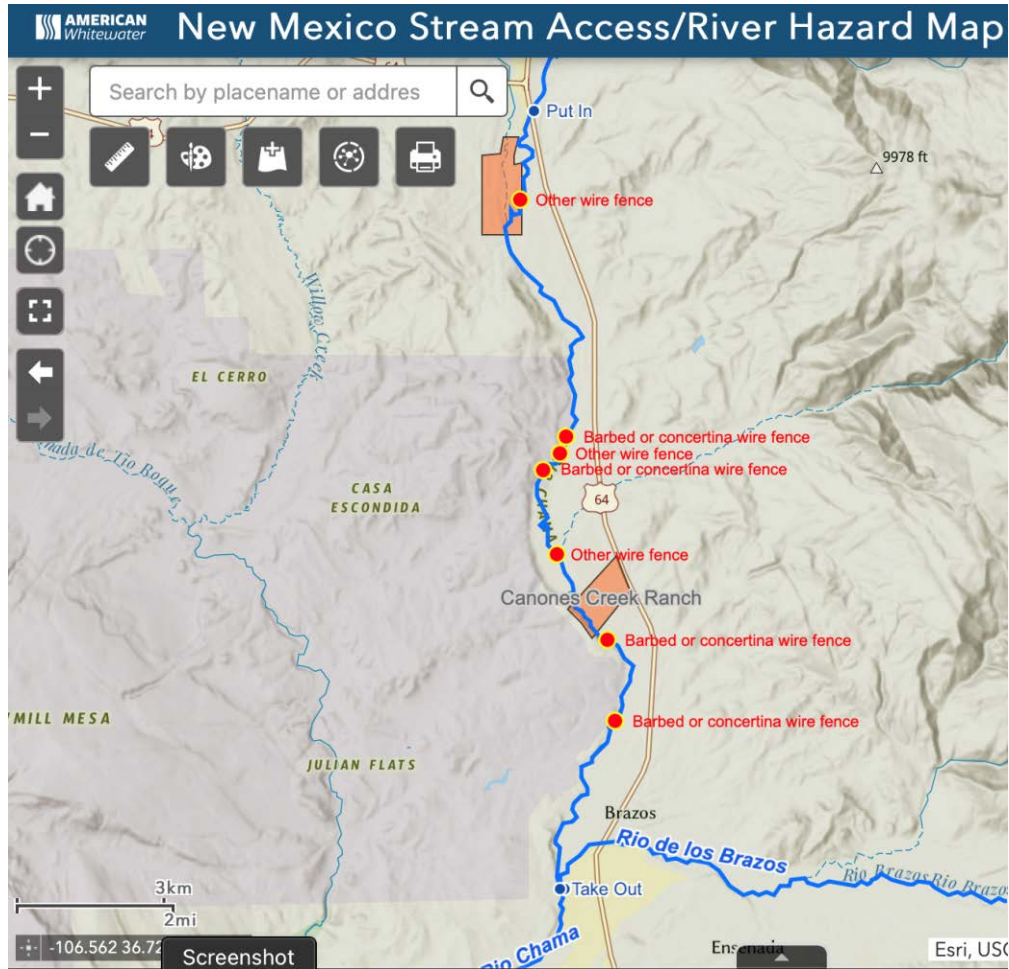
The red dots in the map below show the location of one low cable and four hazardous cross-river fences, numbered 8 through 12, below. Two fences marked with red dots are not included in this complaint.

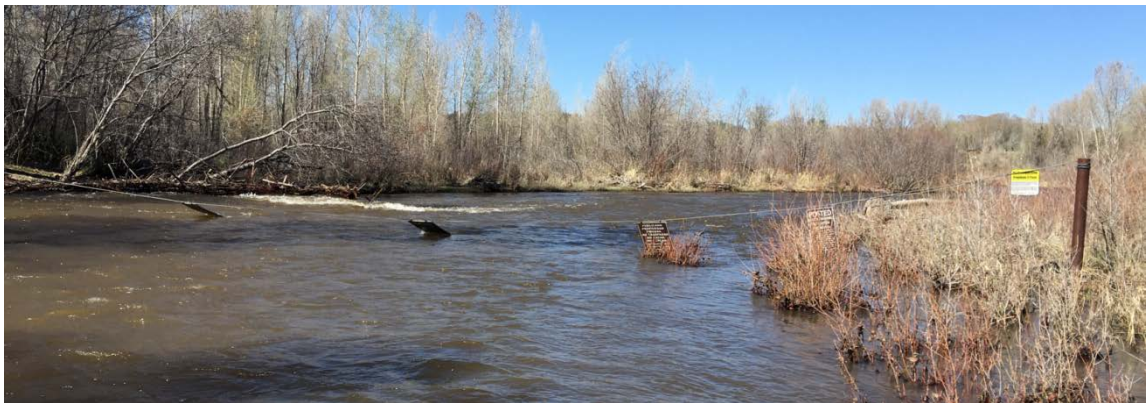
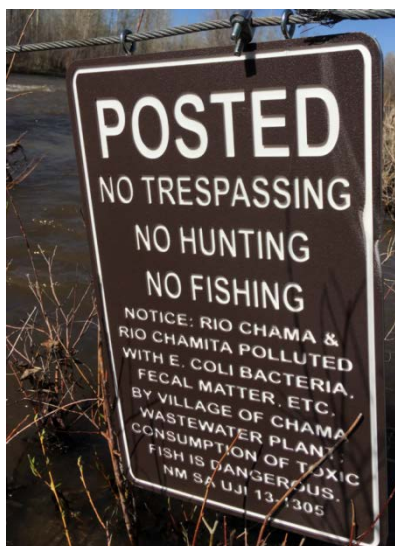
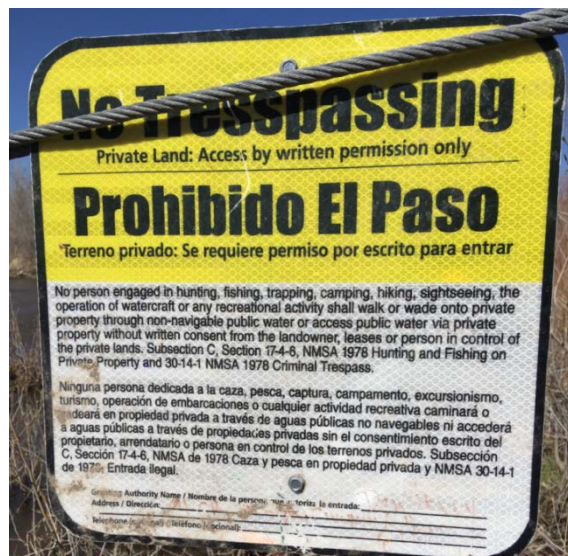
8. **The Upper Rio Chama at the upstream boundary of Trout Stalker Ranch**, believed to be owned by Dan Perry, is blocked by a stout cross-river cable just above or dragging at the river surface, depending on river level. The cable blocks the river and is not flanked by fences on either side. Large no-trespassing signs hang from the cable. Trout Stalker Ranch, upon information and belief, provides improved habitat and food for wild trout in the public river behind a barrier for the exclusive use of patrons.

The yellow no trespassing sign in the photo below is identical to signs posted at the Hersh property on the Pecos River in 2019 and numerous signs now posted along the highway right-of-way associated with the Case #1 properties. A public access to the Rio Chama is immediately downstream of Trout Stalkers Ranch. It cites operation of watercraft .

The downstream boundary of Trout Stalkers Ranch is marked by a cable far above the river that is posted with a different no trespassing sign. A public river access is immediately downstream. Chama Troutstalkers, LLC. was an Intervenor-Respondent in the NM Supreme Court public stream access litigation.

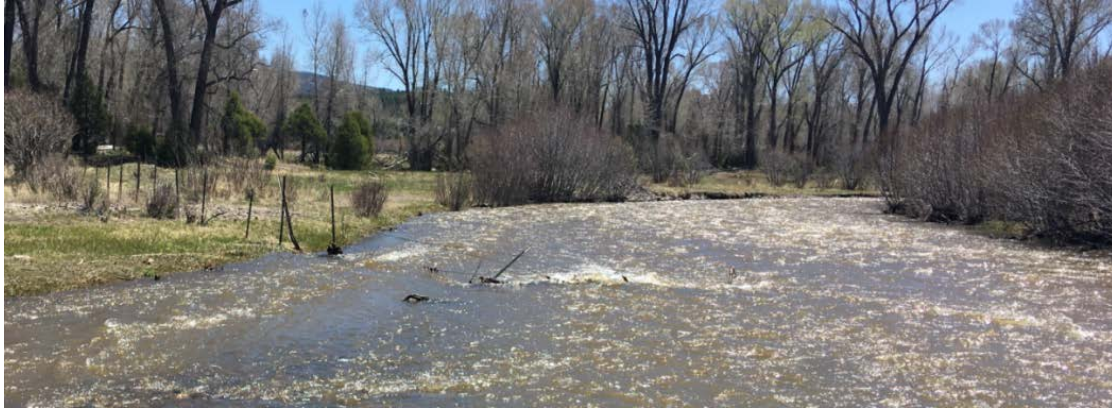
- 9. Gonzales, Mary Ellen Burns.** A diagonal fence across private property transitions to river fence remnants in the water. It is on a property line and was not present in April 2023, but is known to be blown out by high water and subsequently replaced.

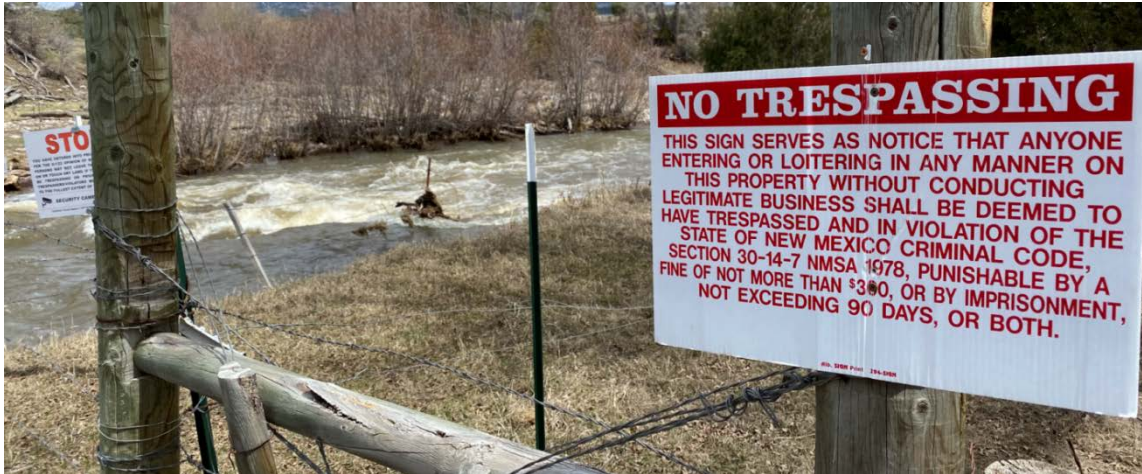
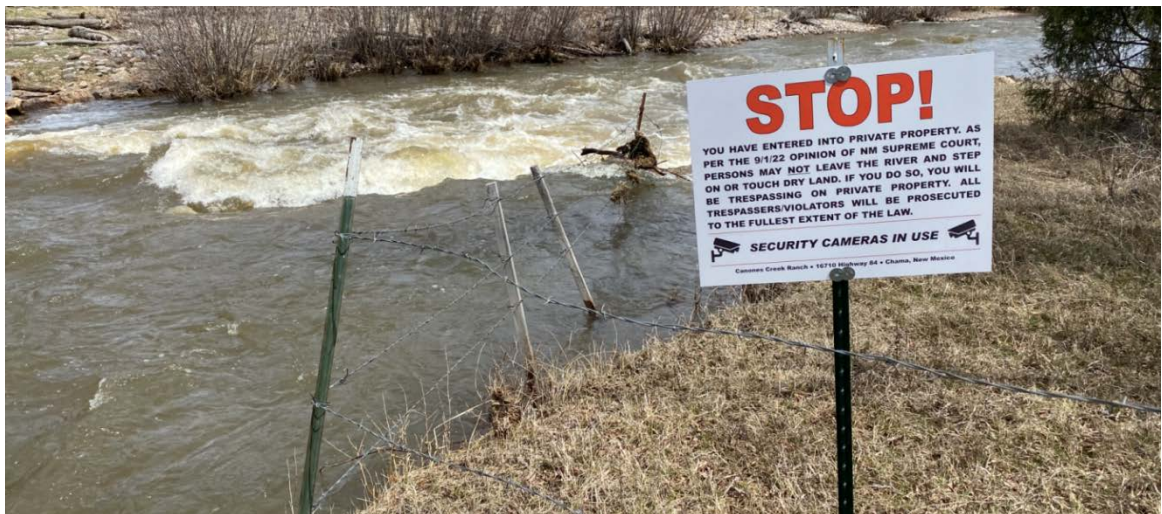
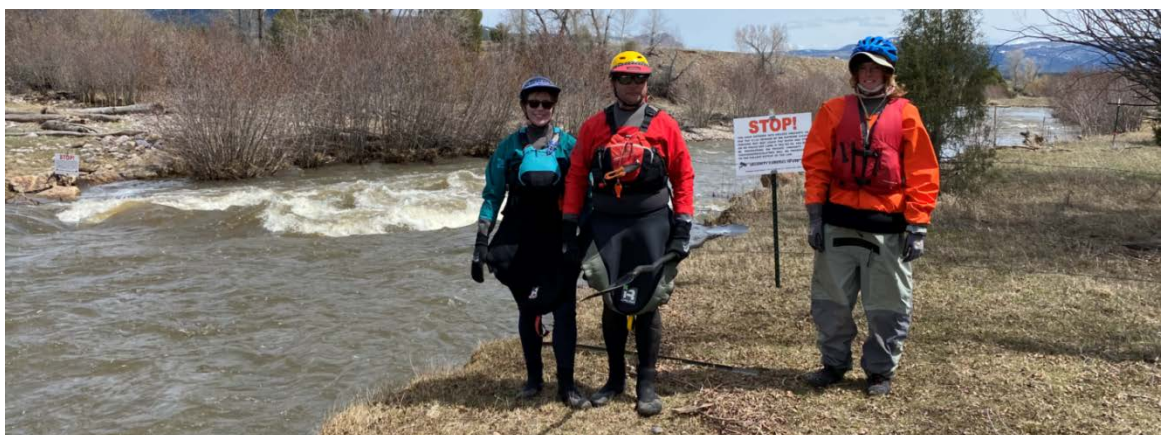
**10. Martinez, Tony L. and Carla L upstream boundary with Gonzales, Mary Ellen Burns Property.** This fence is posted with signs that require a recreationist to stop and not touch the banks. The fence crosses in a whitewater drop. A paddler cannot see if the drop is clear until too late to avoid if it is. Upstream, the fast water without river features (eddies) make it very hard to stop. Safe passage requires a paddler to stop far upstream, then walk down the river right bank to see if the fence is passable. A portage is required if the fence in the drop is intact.

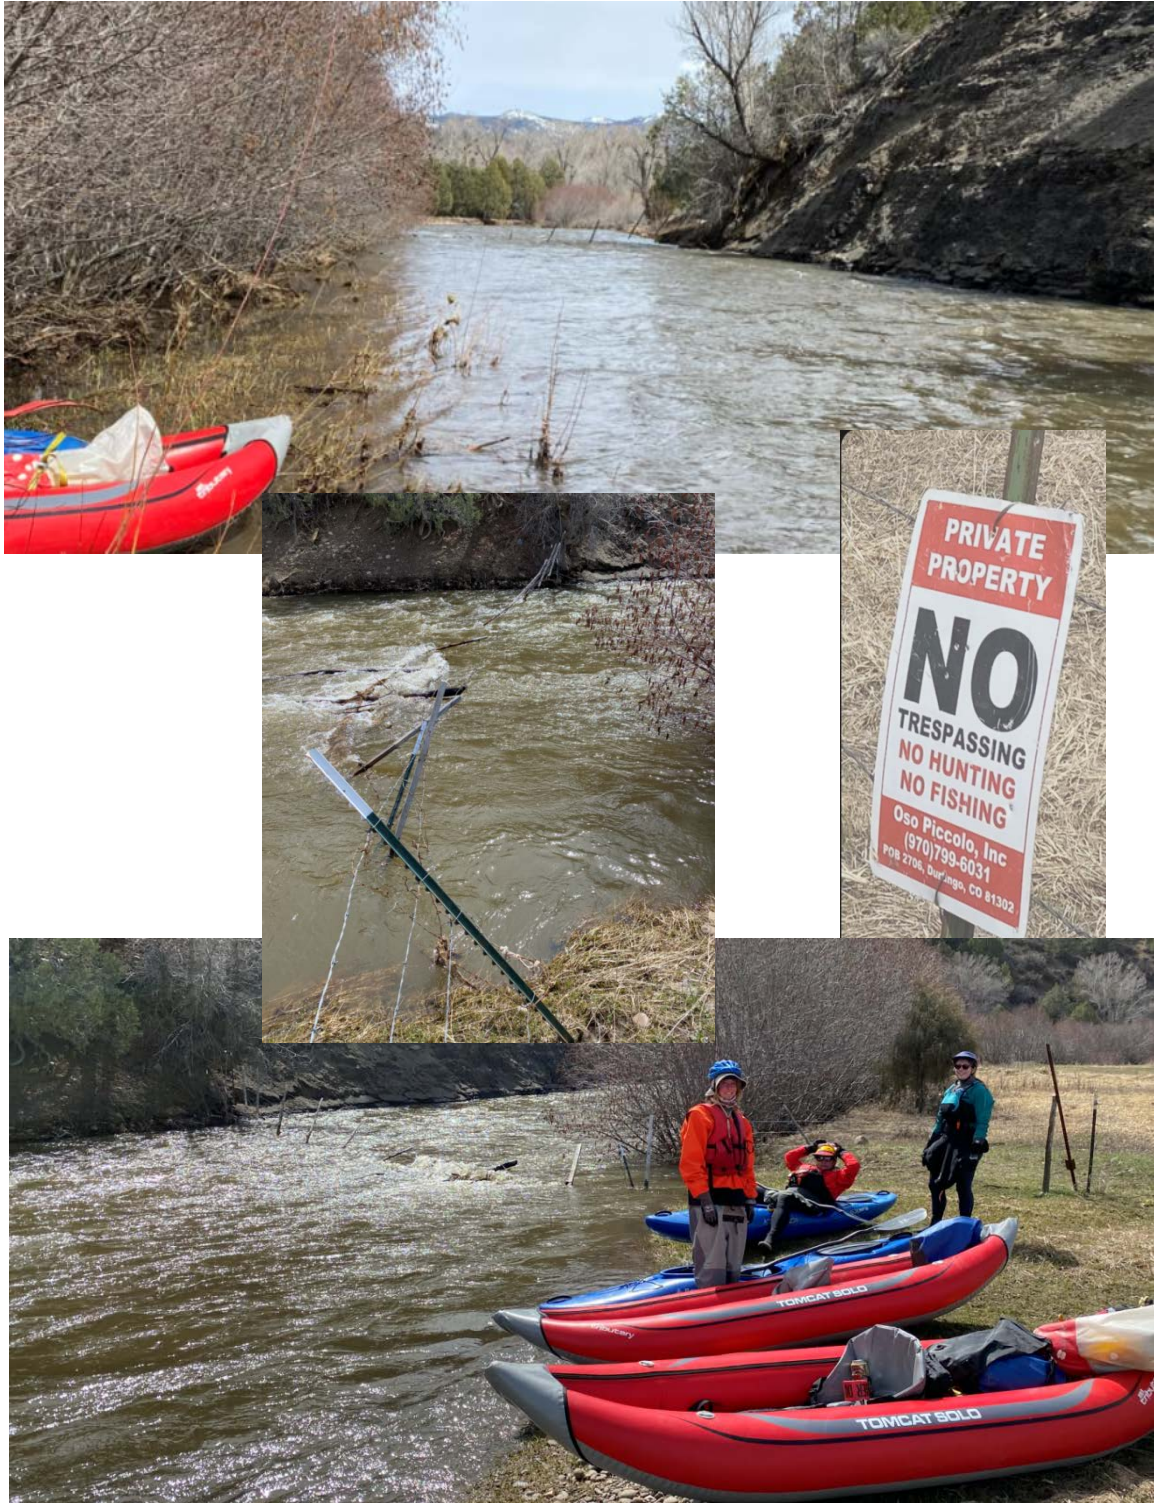
**11. Martinez , Patrick D., and Rose L. downstream boundary with Burns Tract Farm.**

This boundary is marked with a very dangerous barbed wire fence in swift current with no landing. The two photos below are upstream and downstream of the fence. Safe passage requires landing above thick brush on river left for a mandatory portage of about 100 yards. The photos below are in upstream to downstream order.

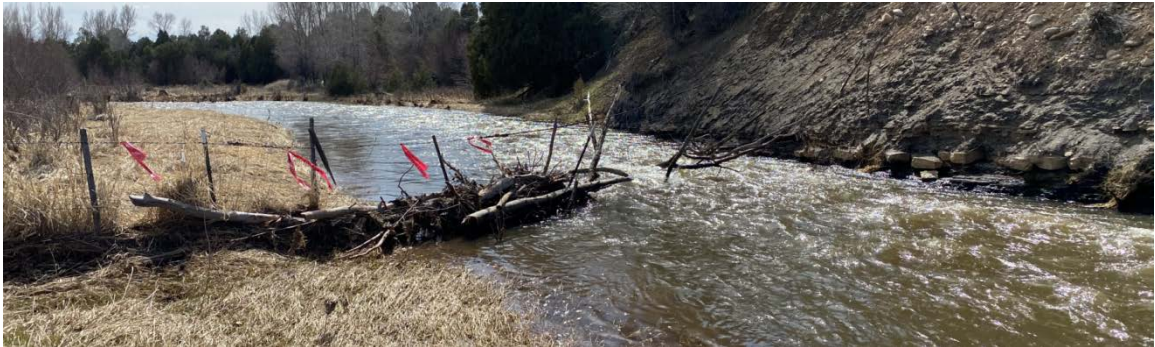
- 12. Sanchez Family Trust.** This fence is not on a property boundary according to OnX. The river has two channels at this location. The left channel is passable in kayaks, but not a raft, under a cross-river cable. This dangerous fence across the right channel, below, could be deadly to an unsuspecting paddler who elected to take the right channel.
