**SUBJECT: COMPLAINT RE UNSAFE OBSTRUCTION OF PADDLERS' UTILIZATION OF THE WATER IN NEW MEXICO'S RIVERS AND STREAMS FOR RECREATION**

**Itemized Complaint to the New Mexico Attorney General re**  
Barricades and dangerous river fences on the Upper Rio Chama and the Upper Pecos River  
That deny or block recreational access and are life-safety hazards.  
Prepared by the Adobe Whitewater Club of New Mexico and the New Mexico  
Paddlers Coalition, incorporated New Mexico not for profit community organizations.  
September 15, 2023

### UPPER PECOS RIVER, Cowles to Pecos

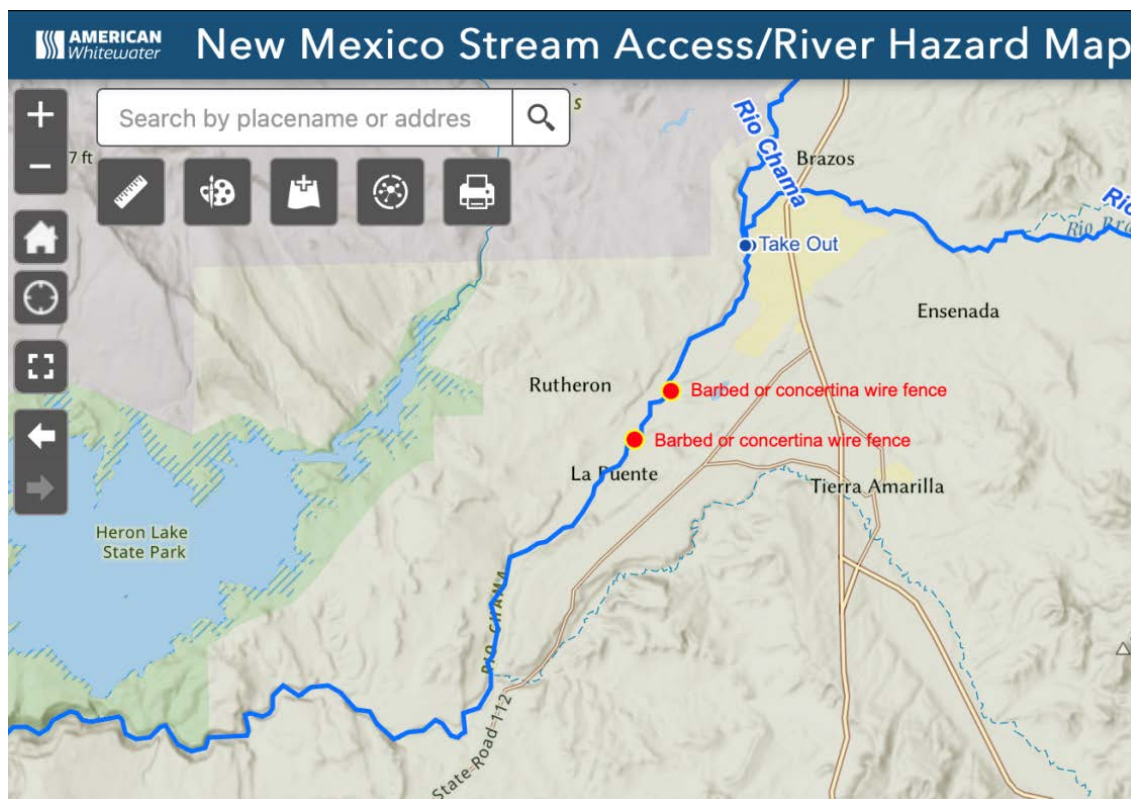
Two dangerous fences cross the river just downstream on the beautiful river reach named the Big Mama Chama. Locations are shown below.

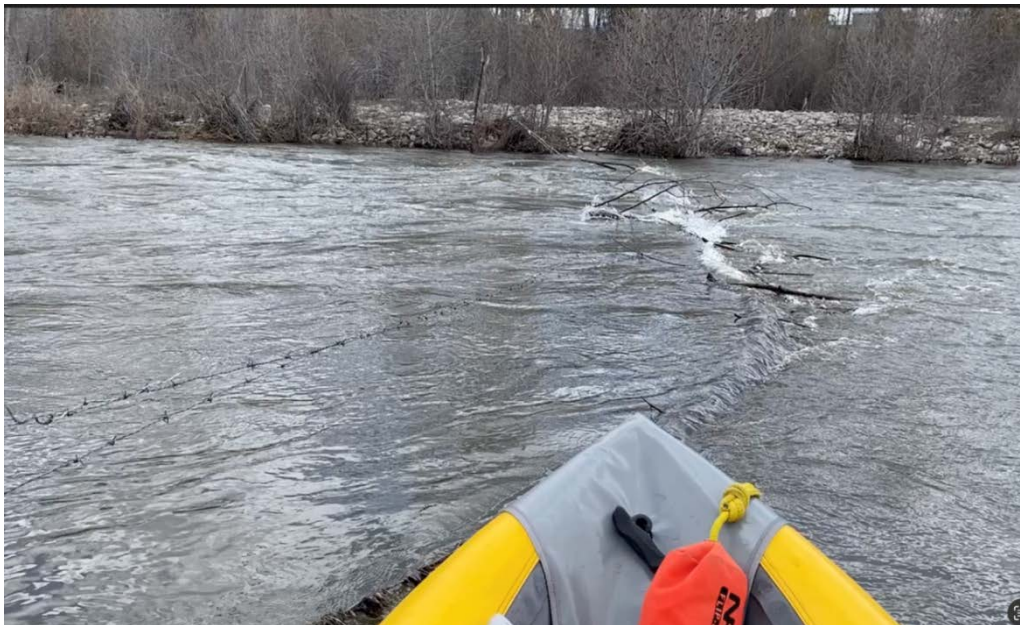
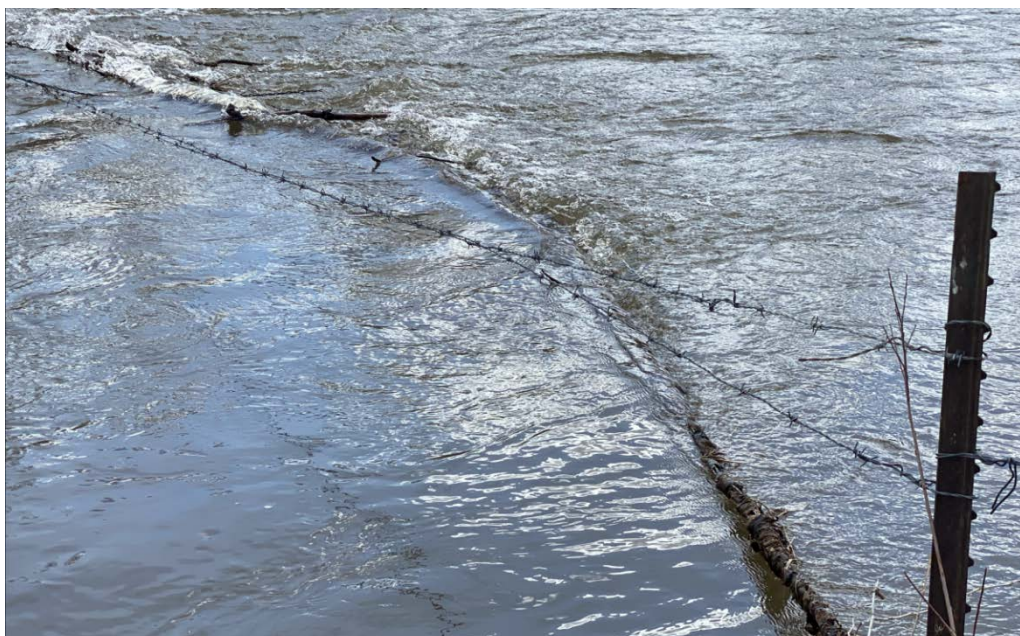
**13. Casados, Russell P. (Trustee) Casados Revocable Trust boundary with Manzanares, Antonio J. and Molly.** A very dangerous, almost invisible-to-approaching-paddlers fence is in current around a right-hand bend at the end of the long, fast “quarry” rapid. River-right brush has grown thick and obscures the fence/gate, making the fence hard to see. The thick brush makes it hard to stop and get off the river above the fence for the mandatory portage. Even paddlers who are familiar with this fence have a hard time seeing it because most of it is in the water. Two invisible-from-upstream barbed wire strands are attached only on either side of the river at a height that would be at head or chest level to a kayaker. The fence cannot be photographed from upstream because of brush, swift current, and the curvature of the river.

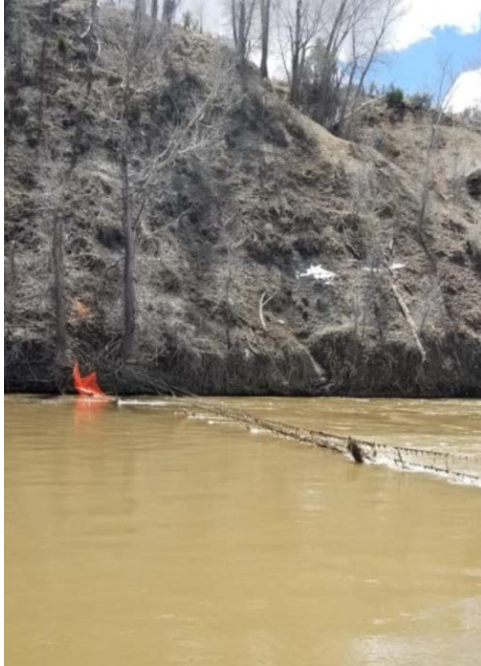
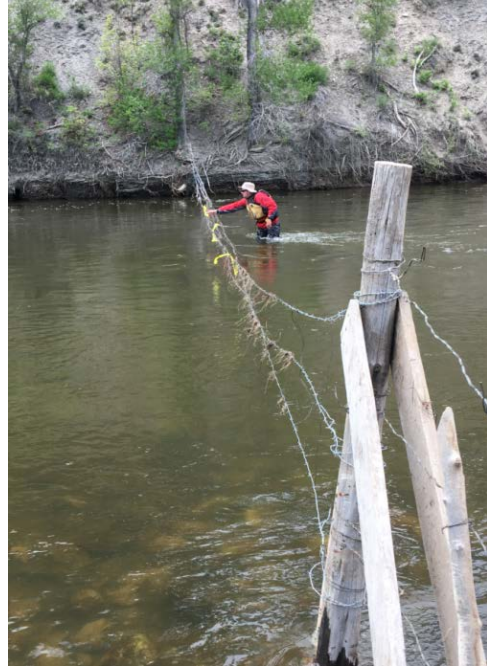
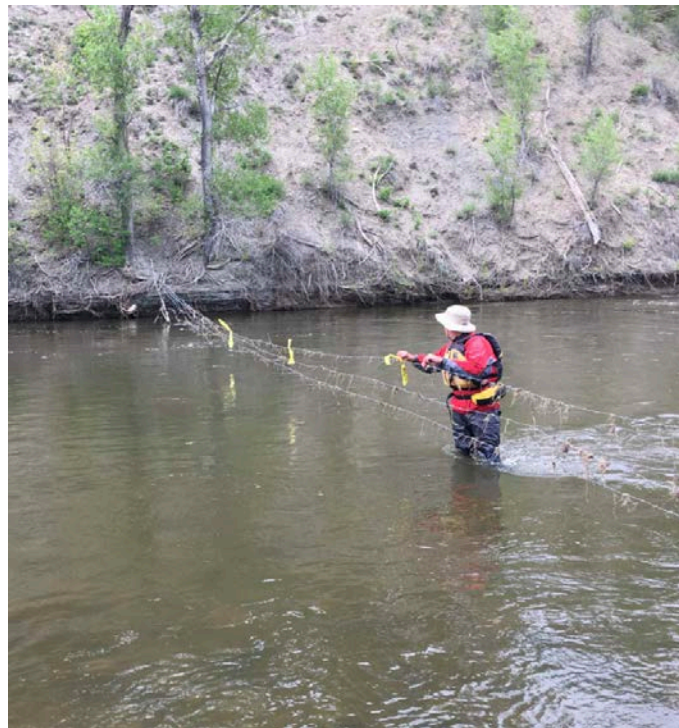
**14. Unknown owner.** This fence is in poor repair, in the water., and requires a mandatory portage The fence in the river is not flanked by functional fences on either side.
